PUBLIC WORKS CENTER PEARL HARBOR FLEET MOORINGS UNDERWATER INSPECTION REPORT

SEPTEMBER 1983

OCEAN ENGINEERING
AND CONSTRUCTION PROJECT OFFICE
CHESAPEAKE DIVISION
NAVAL FACILITIES ENGINEERING COMMAND
WASHINGTON, D.C. 20374

FPO-1-83(22)

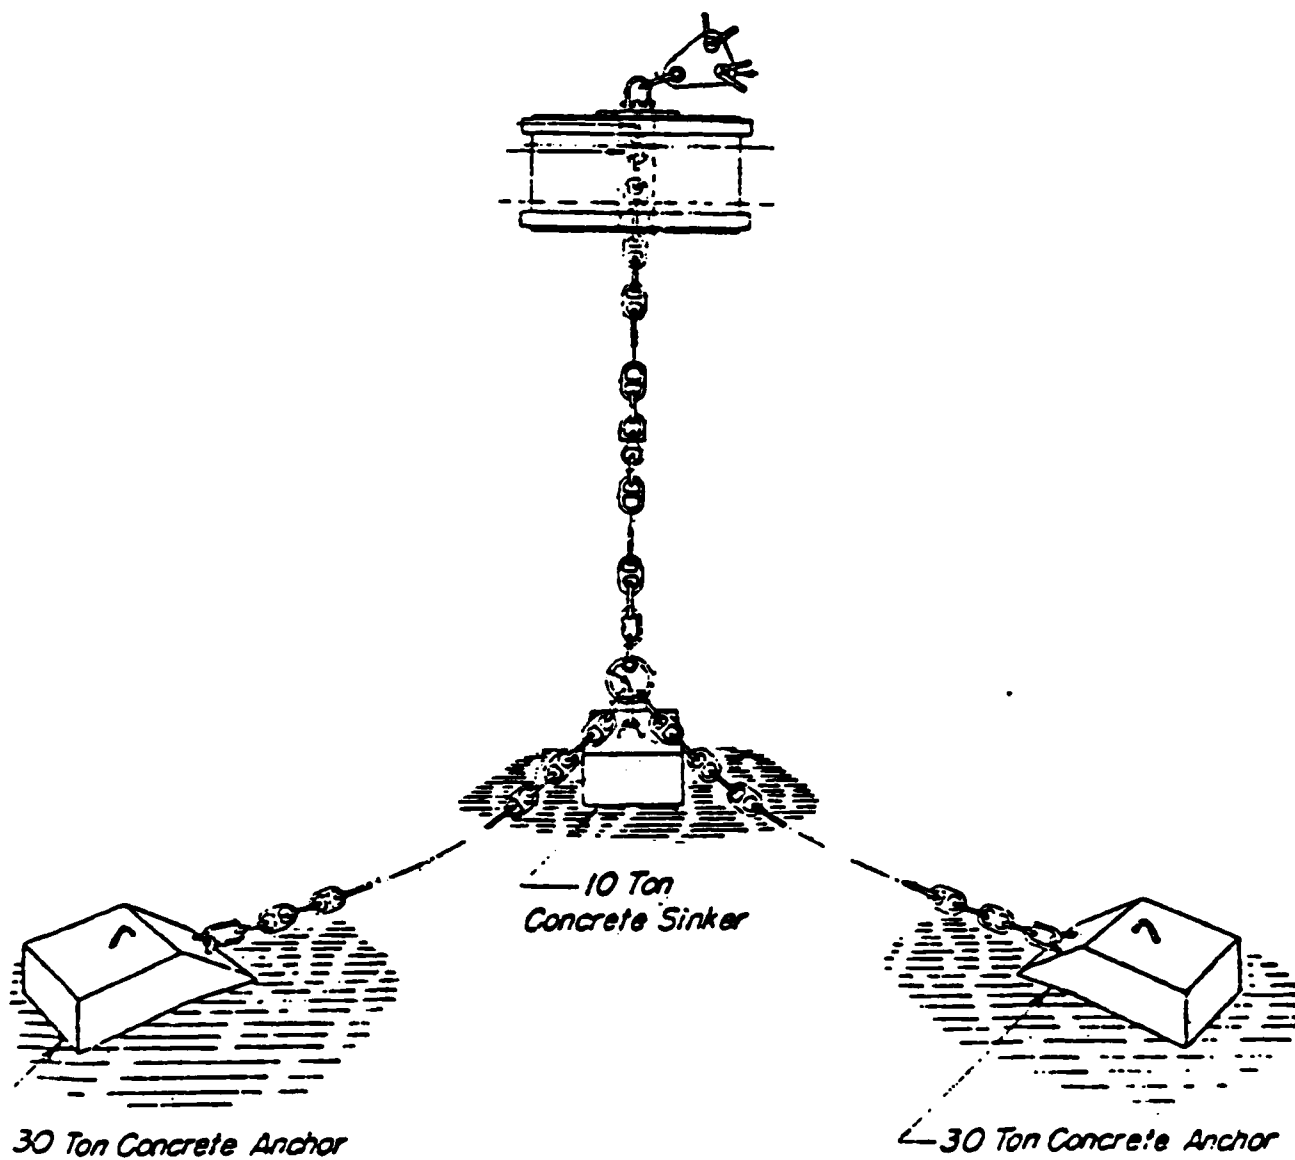
**MOORING AM13
SCHEMATIC DRAWING**

The two 60,000-pound concrete anchors are located side by side in 2 to 3 feet of water near Ford Island and bear about 135°M, 85 feet from the buoy. Each ground leg is joined to a concrete anchor hairpin by a detachable link. The top sections of both anchors are above the surface of the water. The hairpin of one anchor is worn to 1 7/8 inches from its original size of 2 1/4 inches.

This mooring is in unsatisfactory condition for continued fleet use because the anchors and buoy are displaced, and the ground ring measures below 80 percent of its original wire diameter. Recommend that the mooring be recovered, inspected, overhauled, and reinstalled in its proper location.

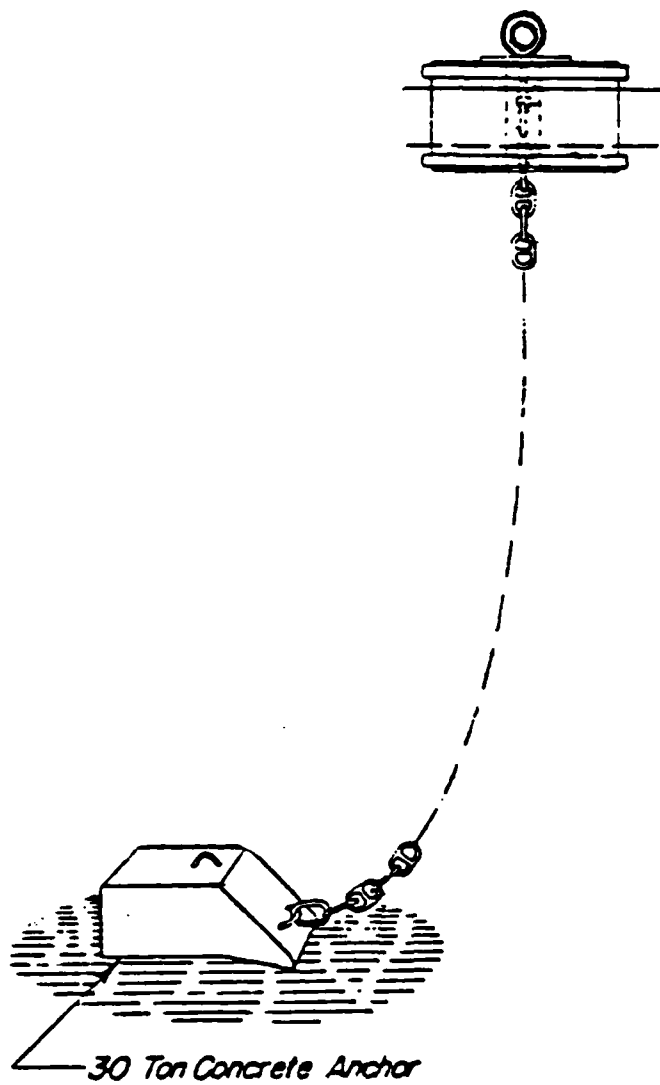
**MOORING AM13A
SCHEMATIC DRAWING**

The buoy is a 12-foot-diameter, 6-foot-high drum-type buoy with a hawsepipe. One section of the top wooden fender is missing but the lower fender and chafing rail are in good condition. Above the water line, the buoy is moderately rusted and some pitting is evident. Below the water line the buoy's hull is covered with moderate marine growth. Top jewelry consists of a shackle and an anchor joining link.

Just above the mud line, the riser chain is badly worn. One single link measurement in this area showed that the chain was worn to about 55 percent of its initial size while a double link measurement was 3 3/8 inches, about 61 percent of the original 2 3/4-inch wire diameter of the chain. The riser is covered with about 2 inches of marine growth and enters the bottom about 39 feet below the surface of the water.

Due to the badly worn riser chain, this mooring is in unsatisfactory condition for continued fleet usage. Recommend that the mooring be recovered and overhauled and replaced with new material.

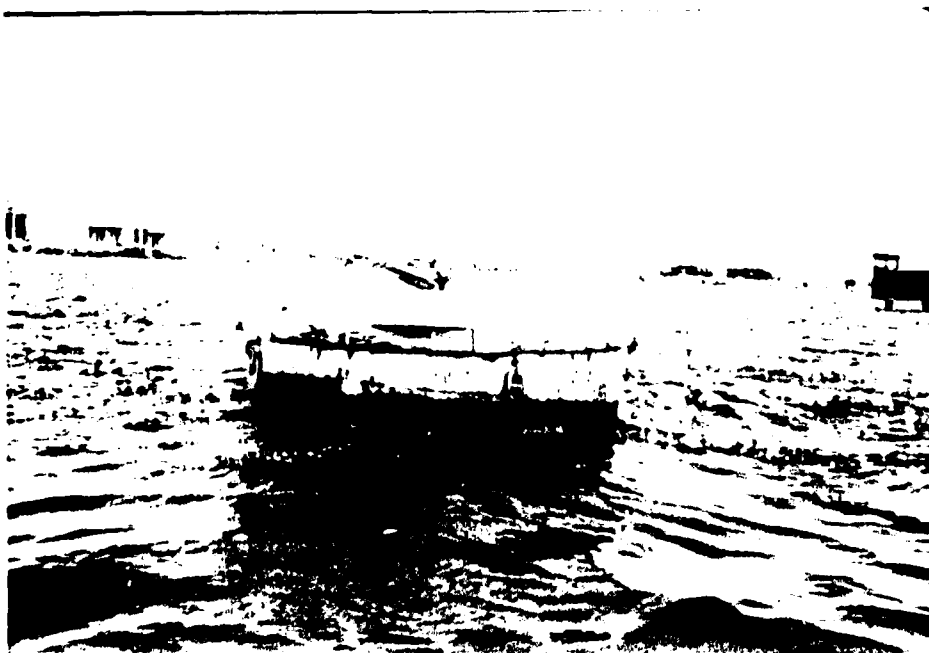
- o The fenders of five mooring buoys (AM13A, D5N, D6M/6S, D11M, and D12S) are either damaged, loose, or missing sections.

Damaged Wooden Fender of Buoy AM13A

- o The fender systems of five of the mooring buoys (AM13A, D5N, D6M/6S, D11M, and D12S) should be repaired/replaced as required.
- o Although the 21 moorings which were determined to be in fair condition should have sufficient capacity to withstand the maximum loads of their current mooring class designations, these moorings should be overhauled and upgraded as soon as feasible in order to meet the original mooring class requirements as shown in the PWC Pearl Harbor Fleet Mooring Data Sheets contained in Annex A.

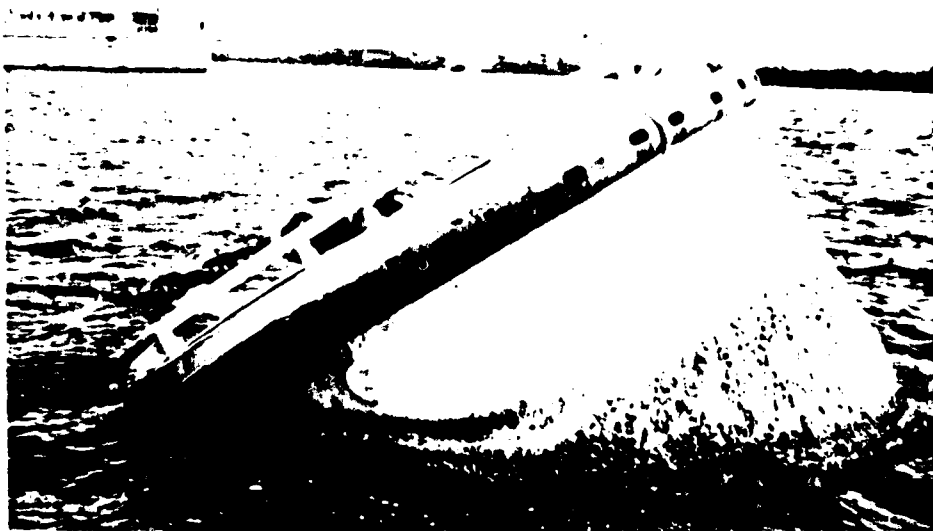
Typical Amount of Marine Growth Below the Water Line

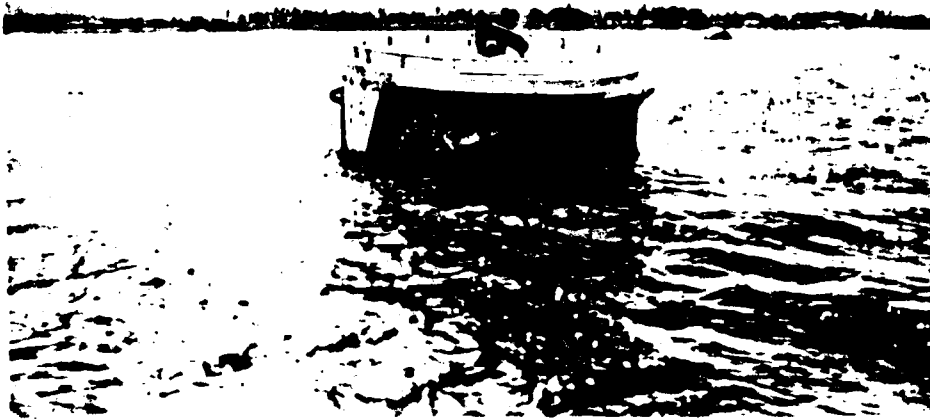
Fender Damage to Buoy D6M/6S

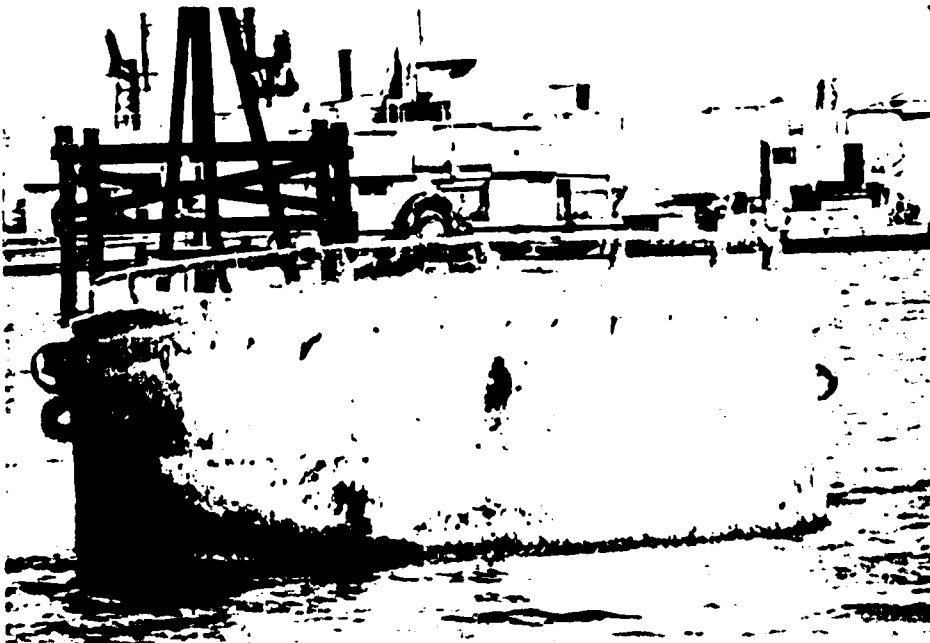
Buoy D12S With Missing Fender

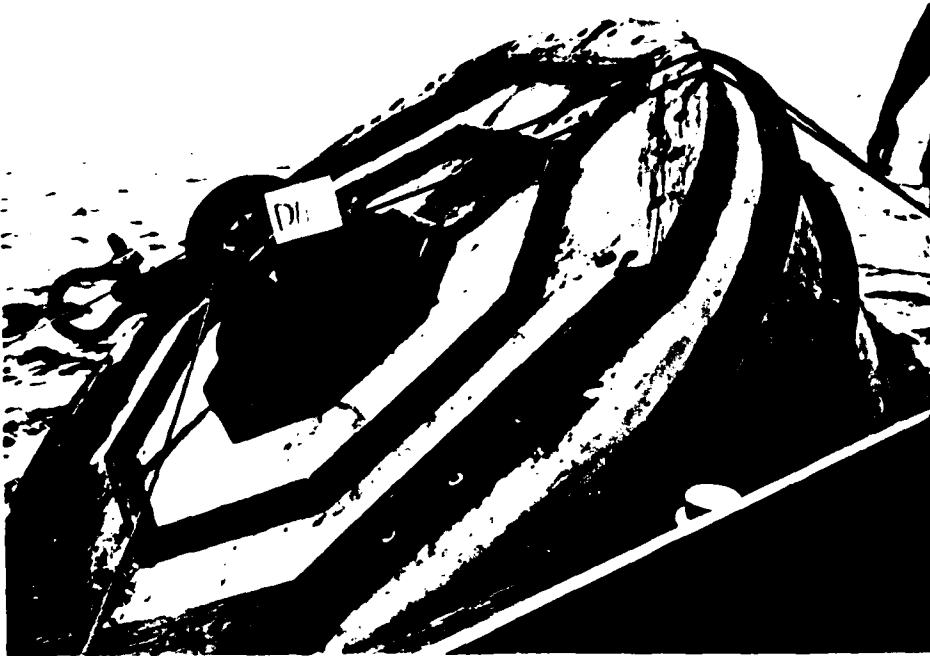
Buoy D11S — An Older Wood Fendered Buoy With a Broken Wooden Chafing Rail

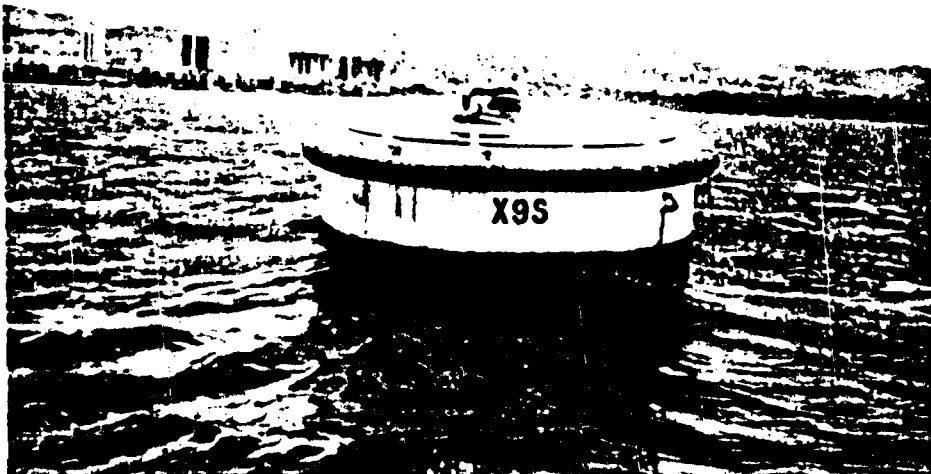
Typical Condition of Recently Overhauled Buoys
